HEATH

TENER MODIFICATION

Dick Ellers K8JLK
426 Central Parkway SE
Warren OH 44483

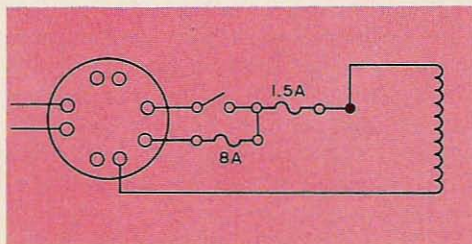
Fig. 1. Modified input wiring.

I cut holes in the rear chassis and case and installed a second fuseholder. I then rewired the power input circuits (see diagram) and also the output of the dc supply. I used decals to identify the fuseholders. Now both fuses are in place at all times,

and the proper fuse is automatically selected when either power supply is connected.
